1. INTRODUCTION

This report, *FEMA-352 – Recommended Postearthquake Evaluation and Repair Criteria for Welded Steel Moment-Frame Buildings*, has been developed by the SAC Joint Venture under contract to the Federal Emergency Management Agency (FEMA) to provide communities and organizations developing programs for the assessment, occupancy status, and repair of welded steel moment-frame buildings that have been subjected to the effects of strong earthquake ground shaking. It is one of a series of companion publications addressing the issue of the seismic performance of steel moment-frame buildings. The set of companion publications includes:

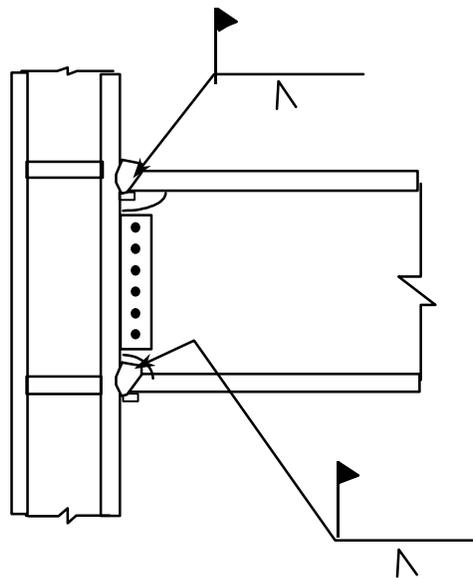
yielding may take the form of plastic hinging in the beams (or less desirably, in the columns), plastic shear deformation in the column panel zones, or through a combination of these mechanisms. It was believed that the typical connection employed in steel moment-frame construction, shown in Figure 1-1, was capable of developing large plastic rotations, on the order of 0.02 radians or larger, without significant strength degradation.

Figure 1-1 Typical Welded Moment-Resisting Connection Prior to 1994

Commentary: The typical moment connection detail employed in most welded steel moment-frames constructed during the period 1960-1994 is that shown in Figure 1-1. Although the properties of structural steels and weld metals employed in fabricating and constructing these connections varied somewhat over the years, the basic configuration was almost universally applied in this construction type during this time period. It is now known that almost all such connections can be subject to fracture at levels of inelastic demand that are significantly below those currently believed to be appropriate. Therefore, following strong earthquake ground shaking, unless suitable evidence is available to indicate that a building does not have vulnerable connections, or if evaluations conducted in accordance with these recommendations indicate that significant damage is unlikely to have occurred, all steel moment-frame buildings constructed during the period 1960-1994 should be considered to be potentially damaged. Suitable evidence that a building does not have vulnerable connections could include original construction documents that portray connection details that are substantially different from those indicated in Figure 1-1.

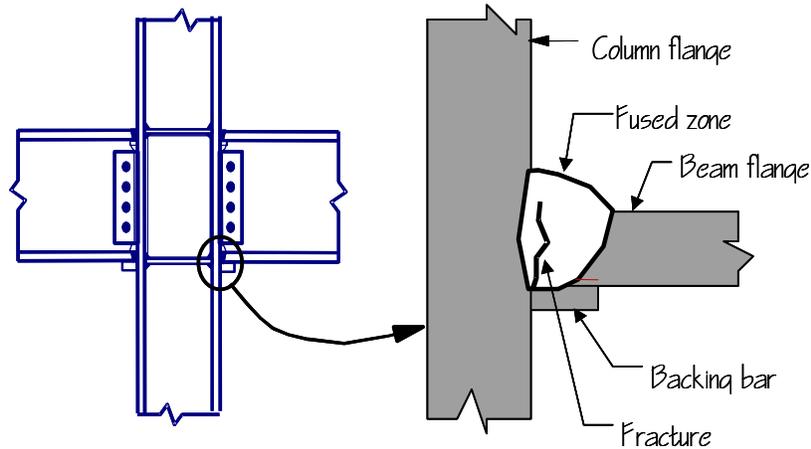
Figure 1-2 Common Zone of Fracture Initiation in Beam-Column Connection

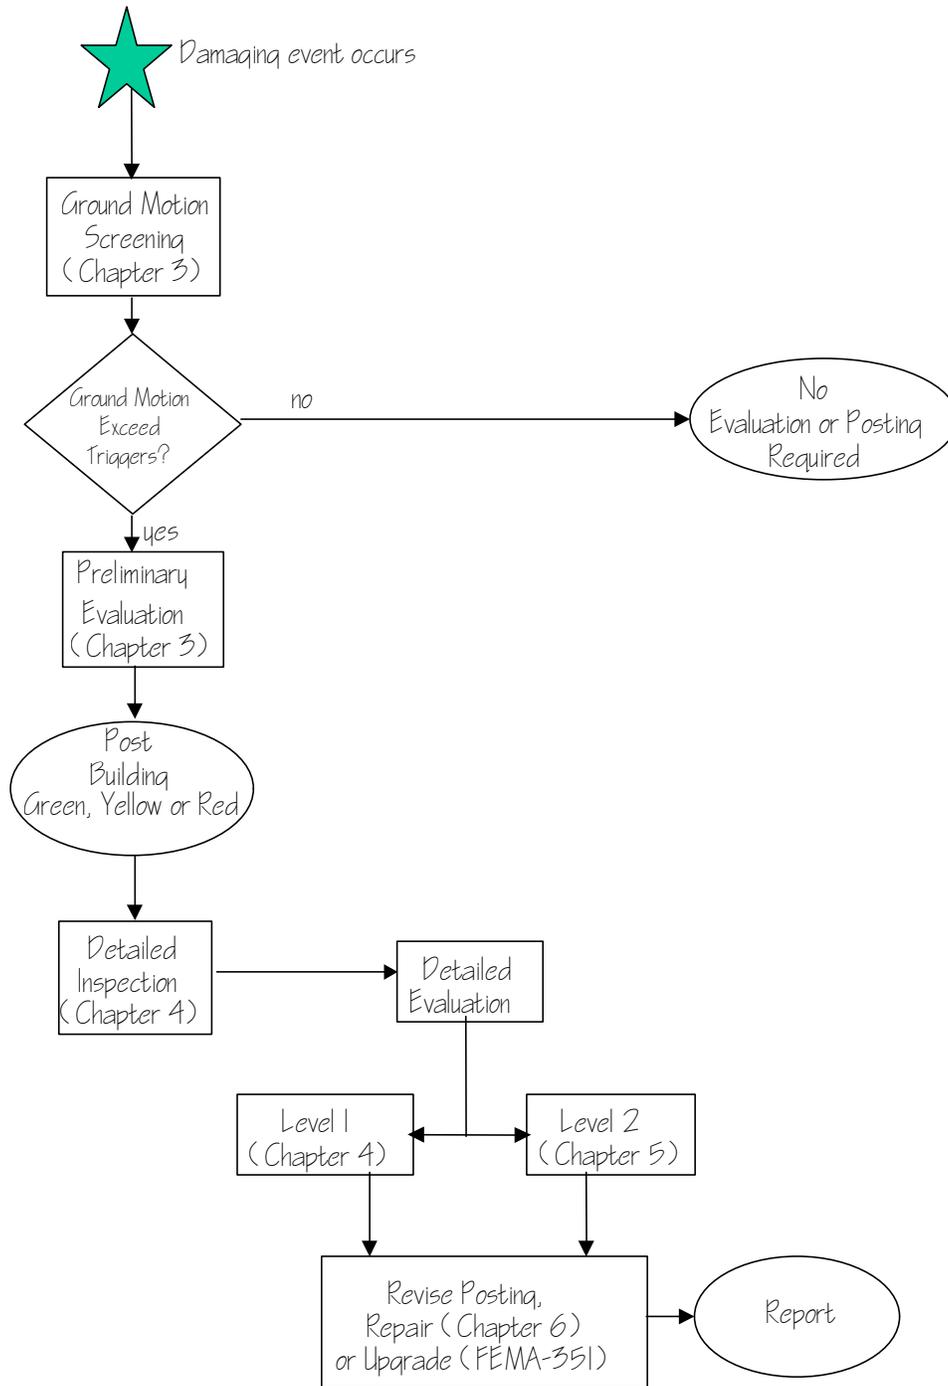
Figure 1-6 Flow Chart for Postearthquake Actions

Postearthquake evaluation of a welded steel moment-frame is a multi-step process (Figure 1-6). The intent is to identify buildings that have sustained sufficient structural damage to compromise future performance, determine the extent and severity of this damage, assess the general implications of the damage with regard to building safety and determine appropriate actions regarding building occupancy and repair. Once a determination is made that a building has sustained significant damage the structural engineer should conduct a more detailed evaluation of the structure's residual structural integrity and safety and develop a detailed plan for repair, upgrade, demolition, or other action, as appropriate.
